2020 ANNUAL STATUS REPORT FOR THE RESTORATION PROGRAM FOR THE SLRR FLOOD RISK MANAGEMENT PROJECT

FIGURE 3A
PROJECT AREA ON AERIAL PHOTOGRAPH AND VEGETATION MANAGEMENT PLAN

CORPS OF ENGINEERS
LOS ANGELES DISTRICT

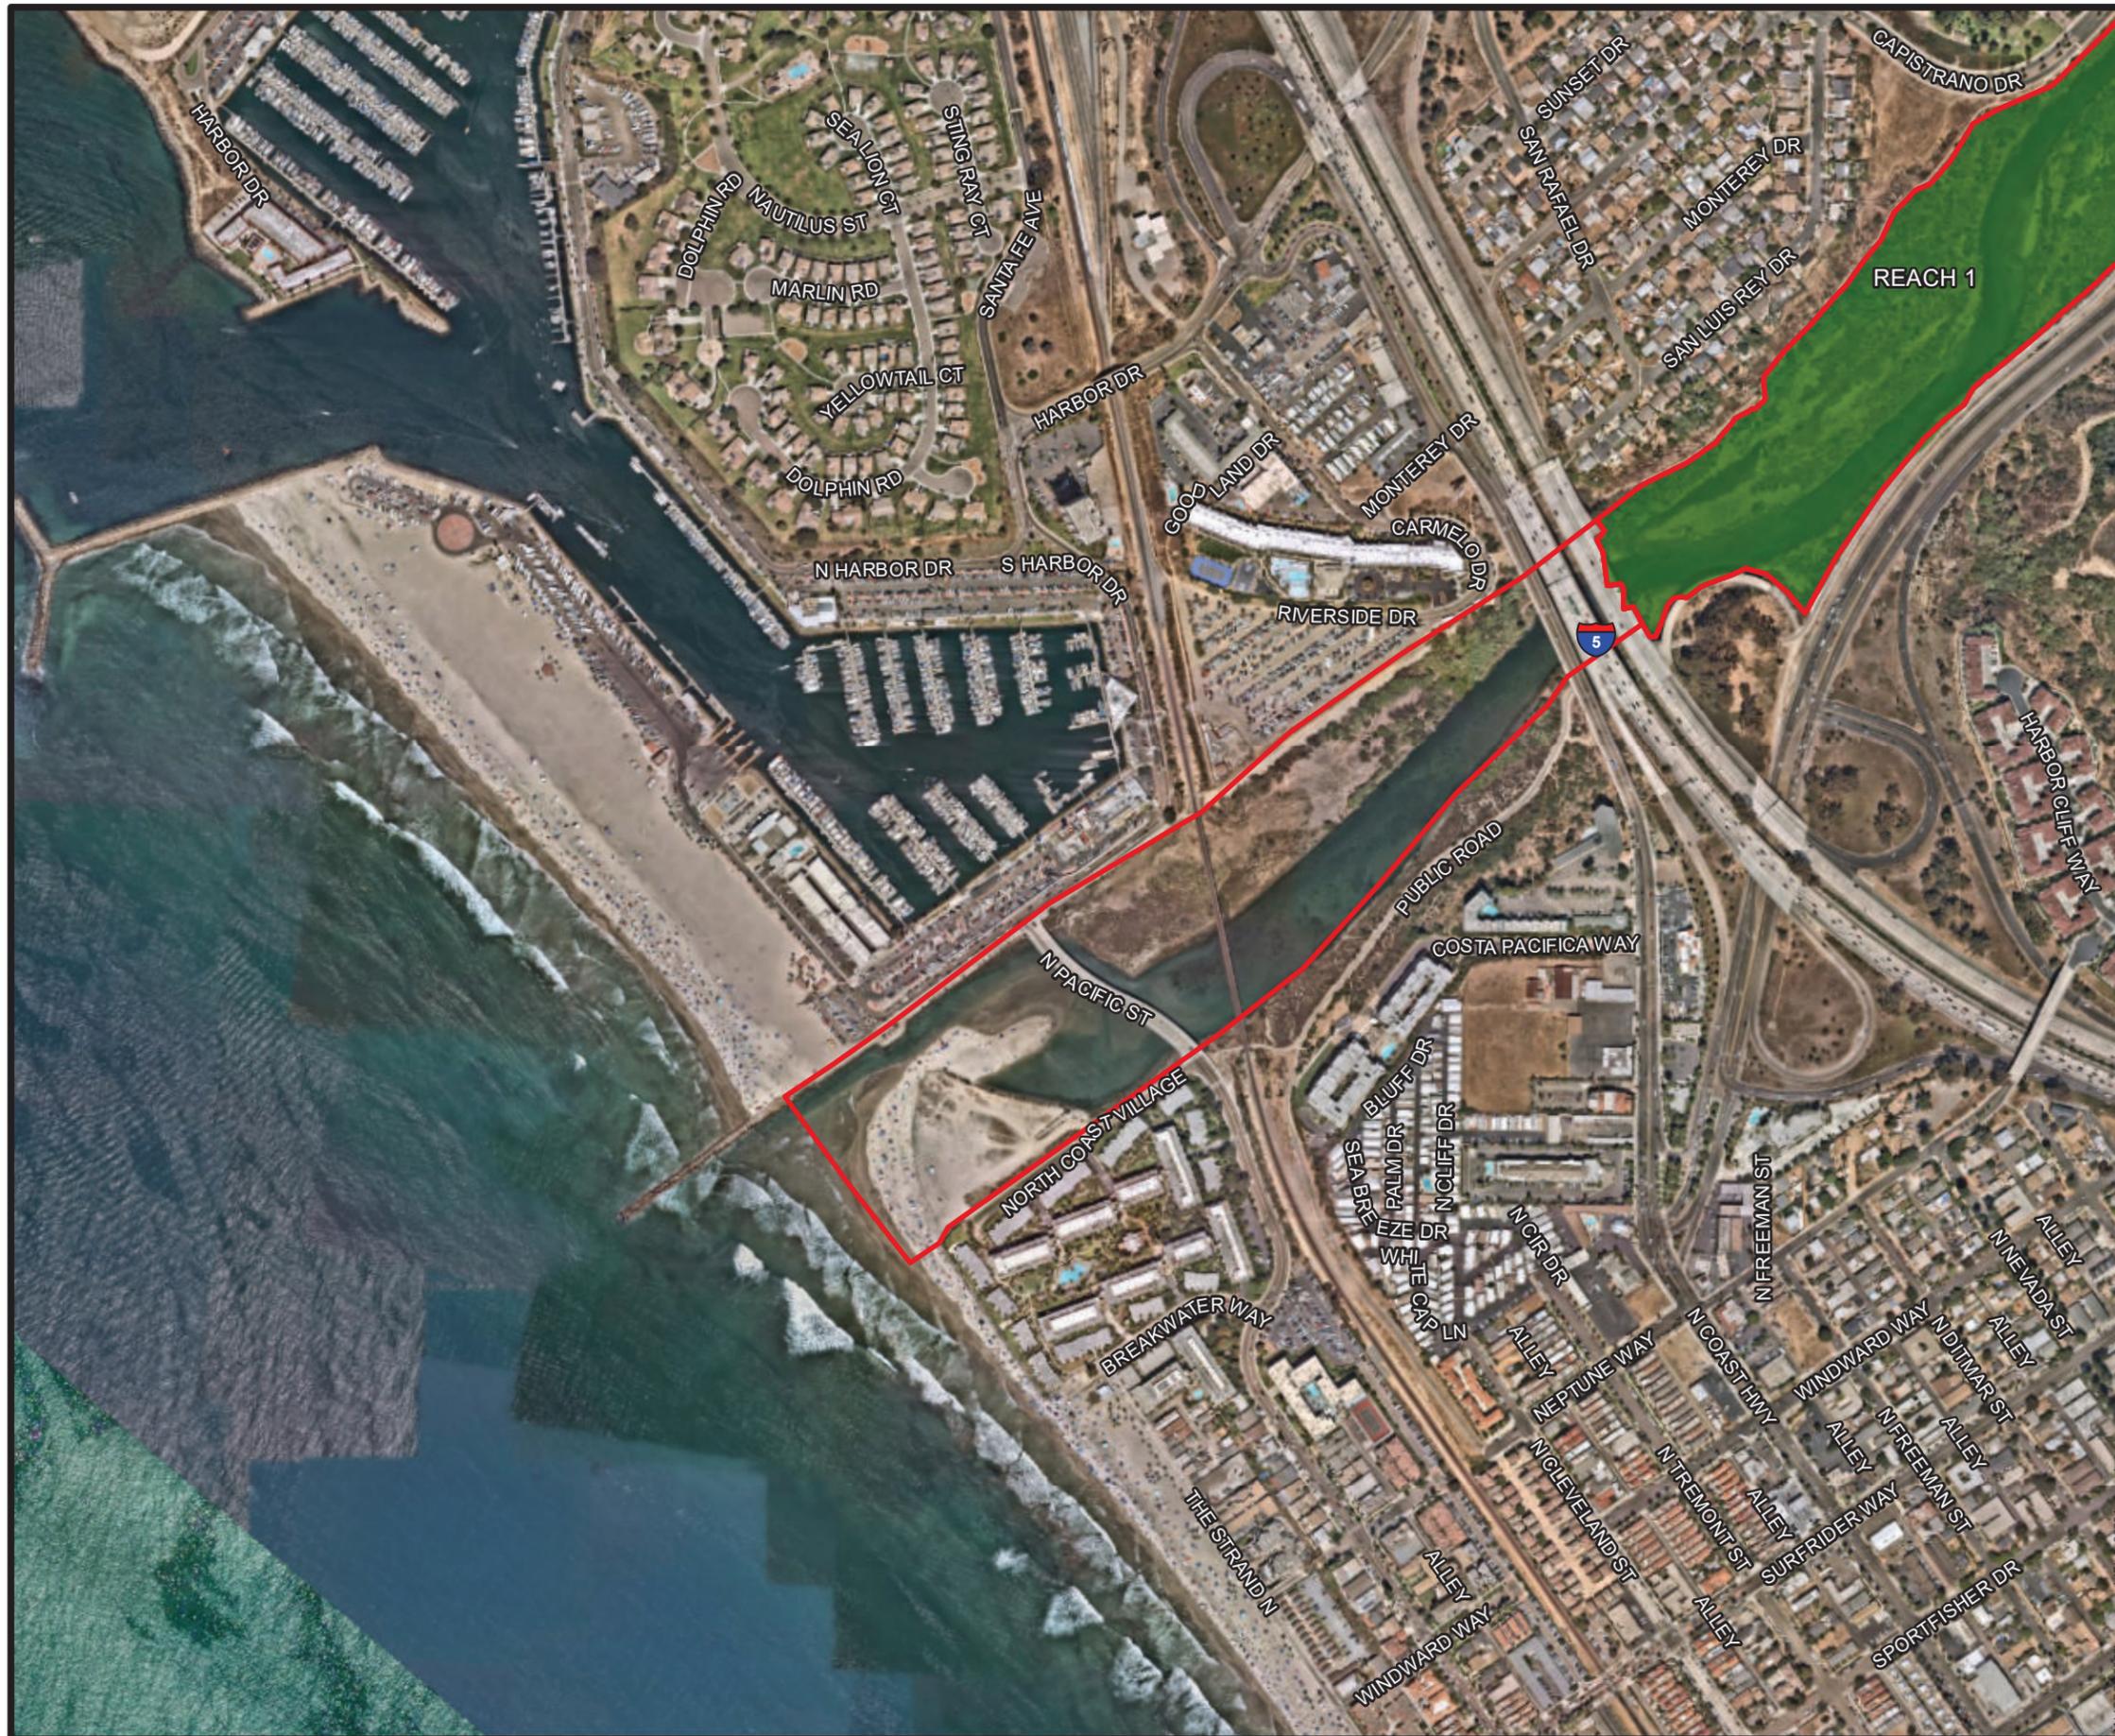
- Flood Risk Management
- Vegetation Management Plan**
- Compensation/Preservation Area

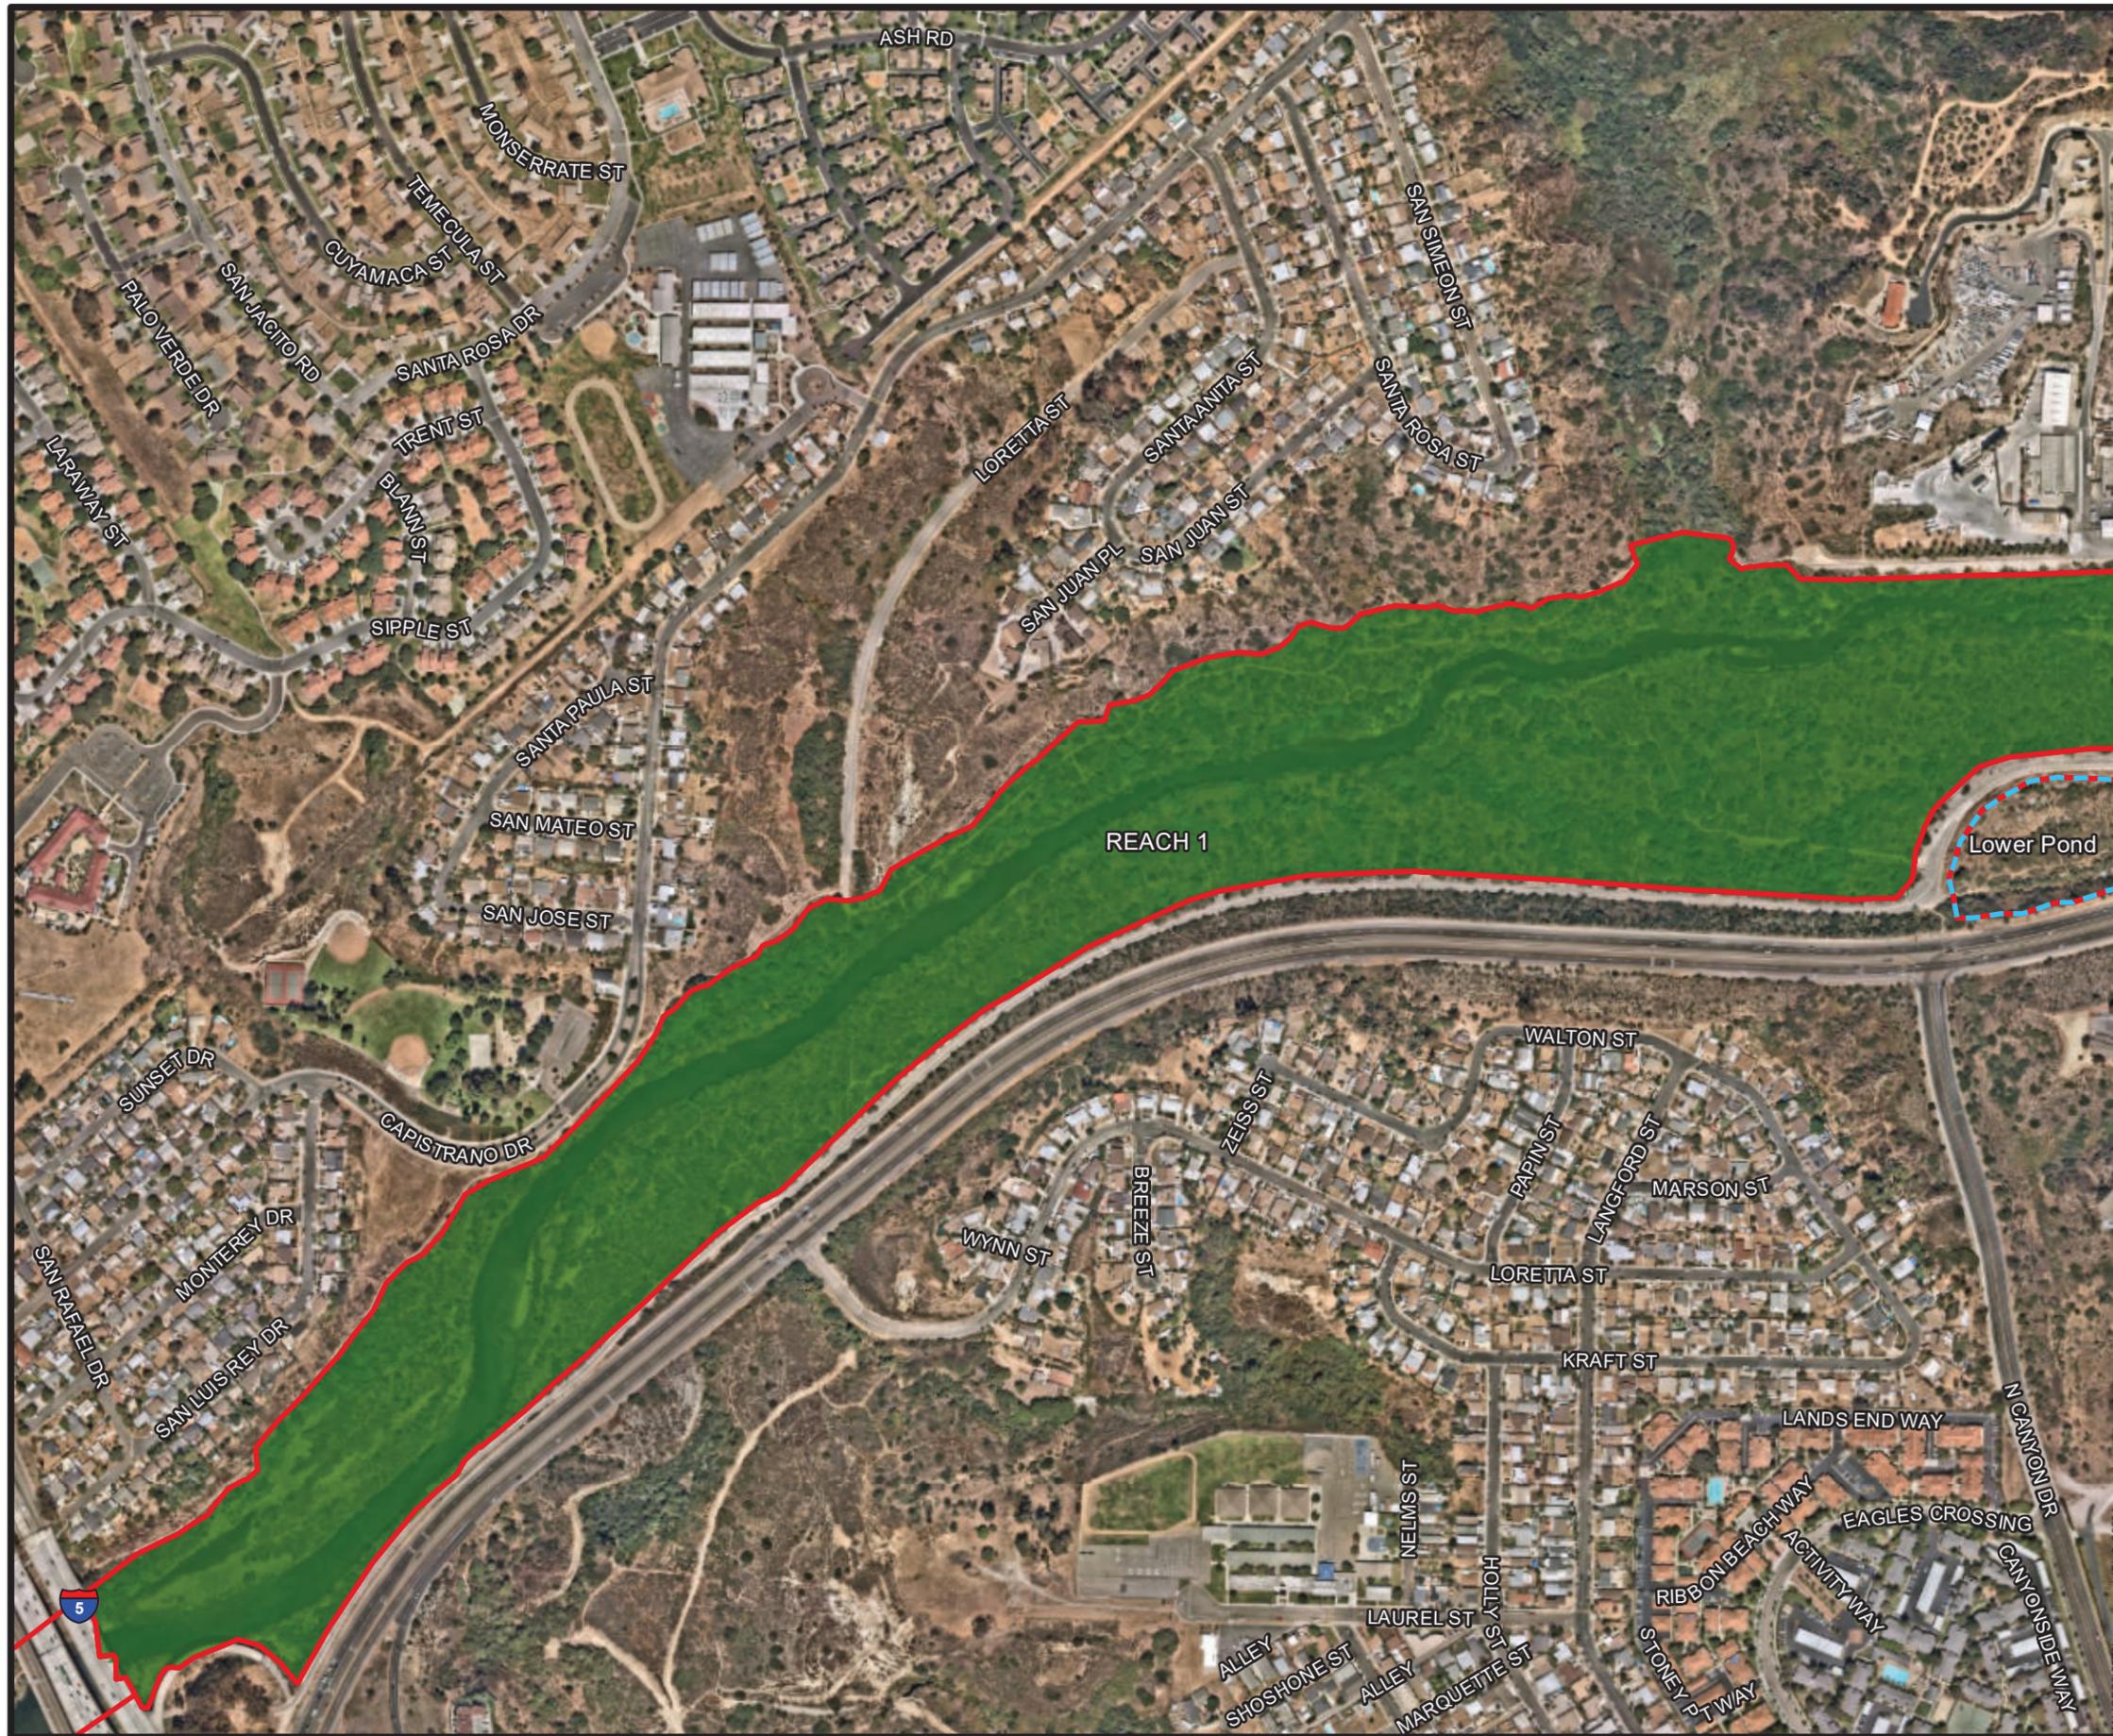
FIGURE 3B
PROJECT AREA ON AERIAL PHOTOGRAPH AND VEGETATION MANAGEMENT PLAN

- Flood Risk Management
- Water Detention/Mitigation Pond
- Vegetation Management Plan**
- Compensation/Preservation Area

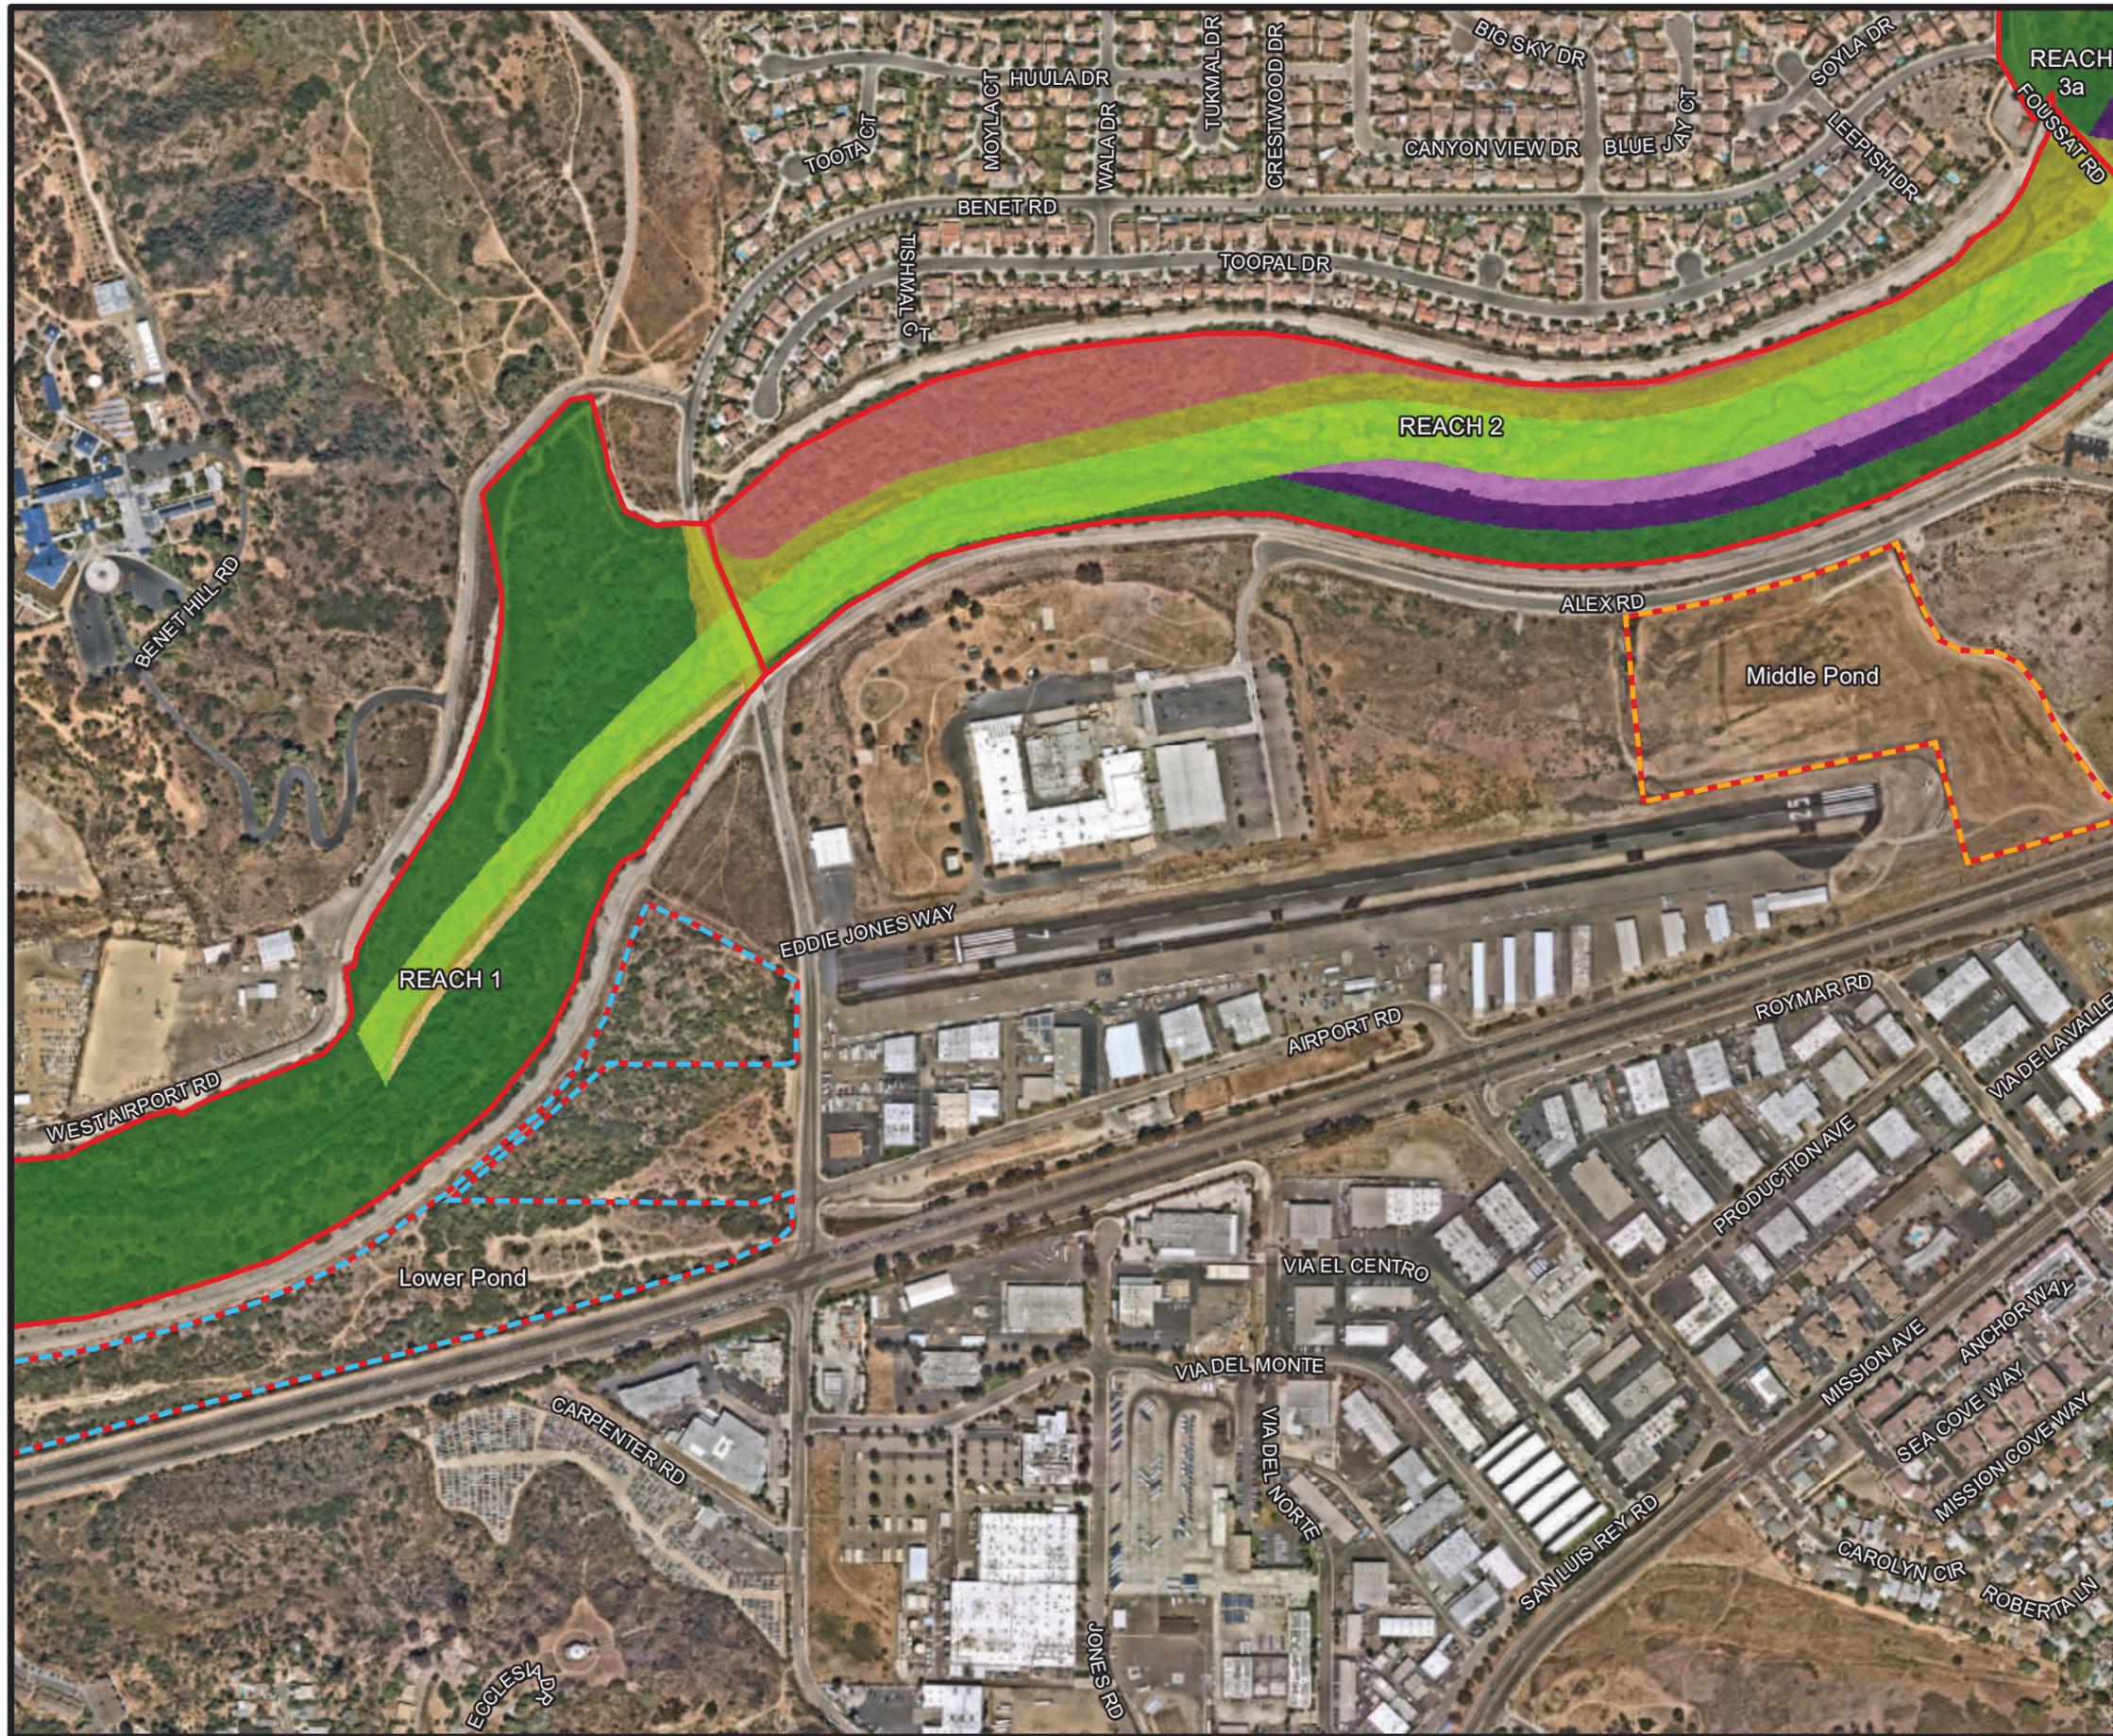
FIGURE 3C
PROJECT AREA ON AERIAL PHOTOGRAPH AND VEGETATION MANAGEMENT PLAN

- Flood Risk Management Area
- Water Detention Pond
- Water Detention/Mitigation Pond
- Vegetation Management Plan**
- Phase 1 Annual Mowing
- Phase 2 Annual Mowing
- Phase 3 Annual Mowing
- 1st 5-Year Rotational Mowing (Rotation 1)
- 2nd 5-Year Rotational Mowing (Rotation 2)
- Compensation/Preservation Area
- Unmaintained Vegetation

SLRR Vegetation Management Plan Acres						
Boundary	Reach 1	Reach 2	Reach 3a	Reach 3b	Reach 4	Total
Phase 1 Annual Mowing	9.75	16.95	28.25	15.78	35.43	106.17
Phase 2 Annual Mowing	2.15	9.97	13.14	6.18	12.20	43.64
Phase 3 Annual Mowing	2.14	0	4.03	0	0	6.17
Rotation 1 (1st 10-Year Mowing)	0	3.68	5.90	3.59	12.13	25.30
Rotation 2 (2nd 10-Year Mowing)	0	4.38	5.08	3.88	12.10	25.44
Compensation/Preservation Area	117.90	7.82	49.27	0.89	1.96	177.84
Unmaintained Vegetation	0.01	9.54	10.12	7.50	12.46	39.63
Total	131.95	52.34	115.80	37.83	86.29	424.20

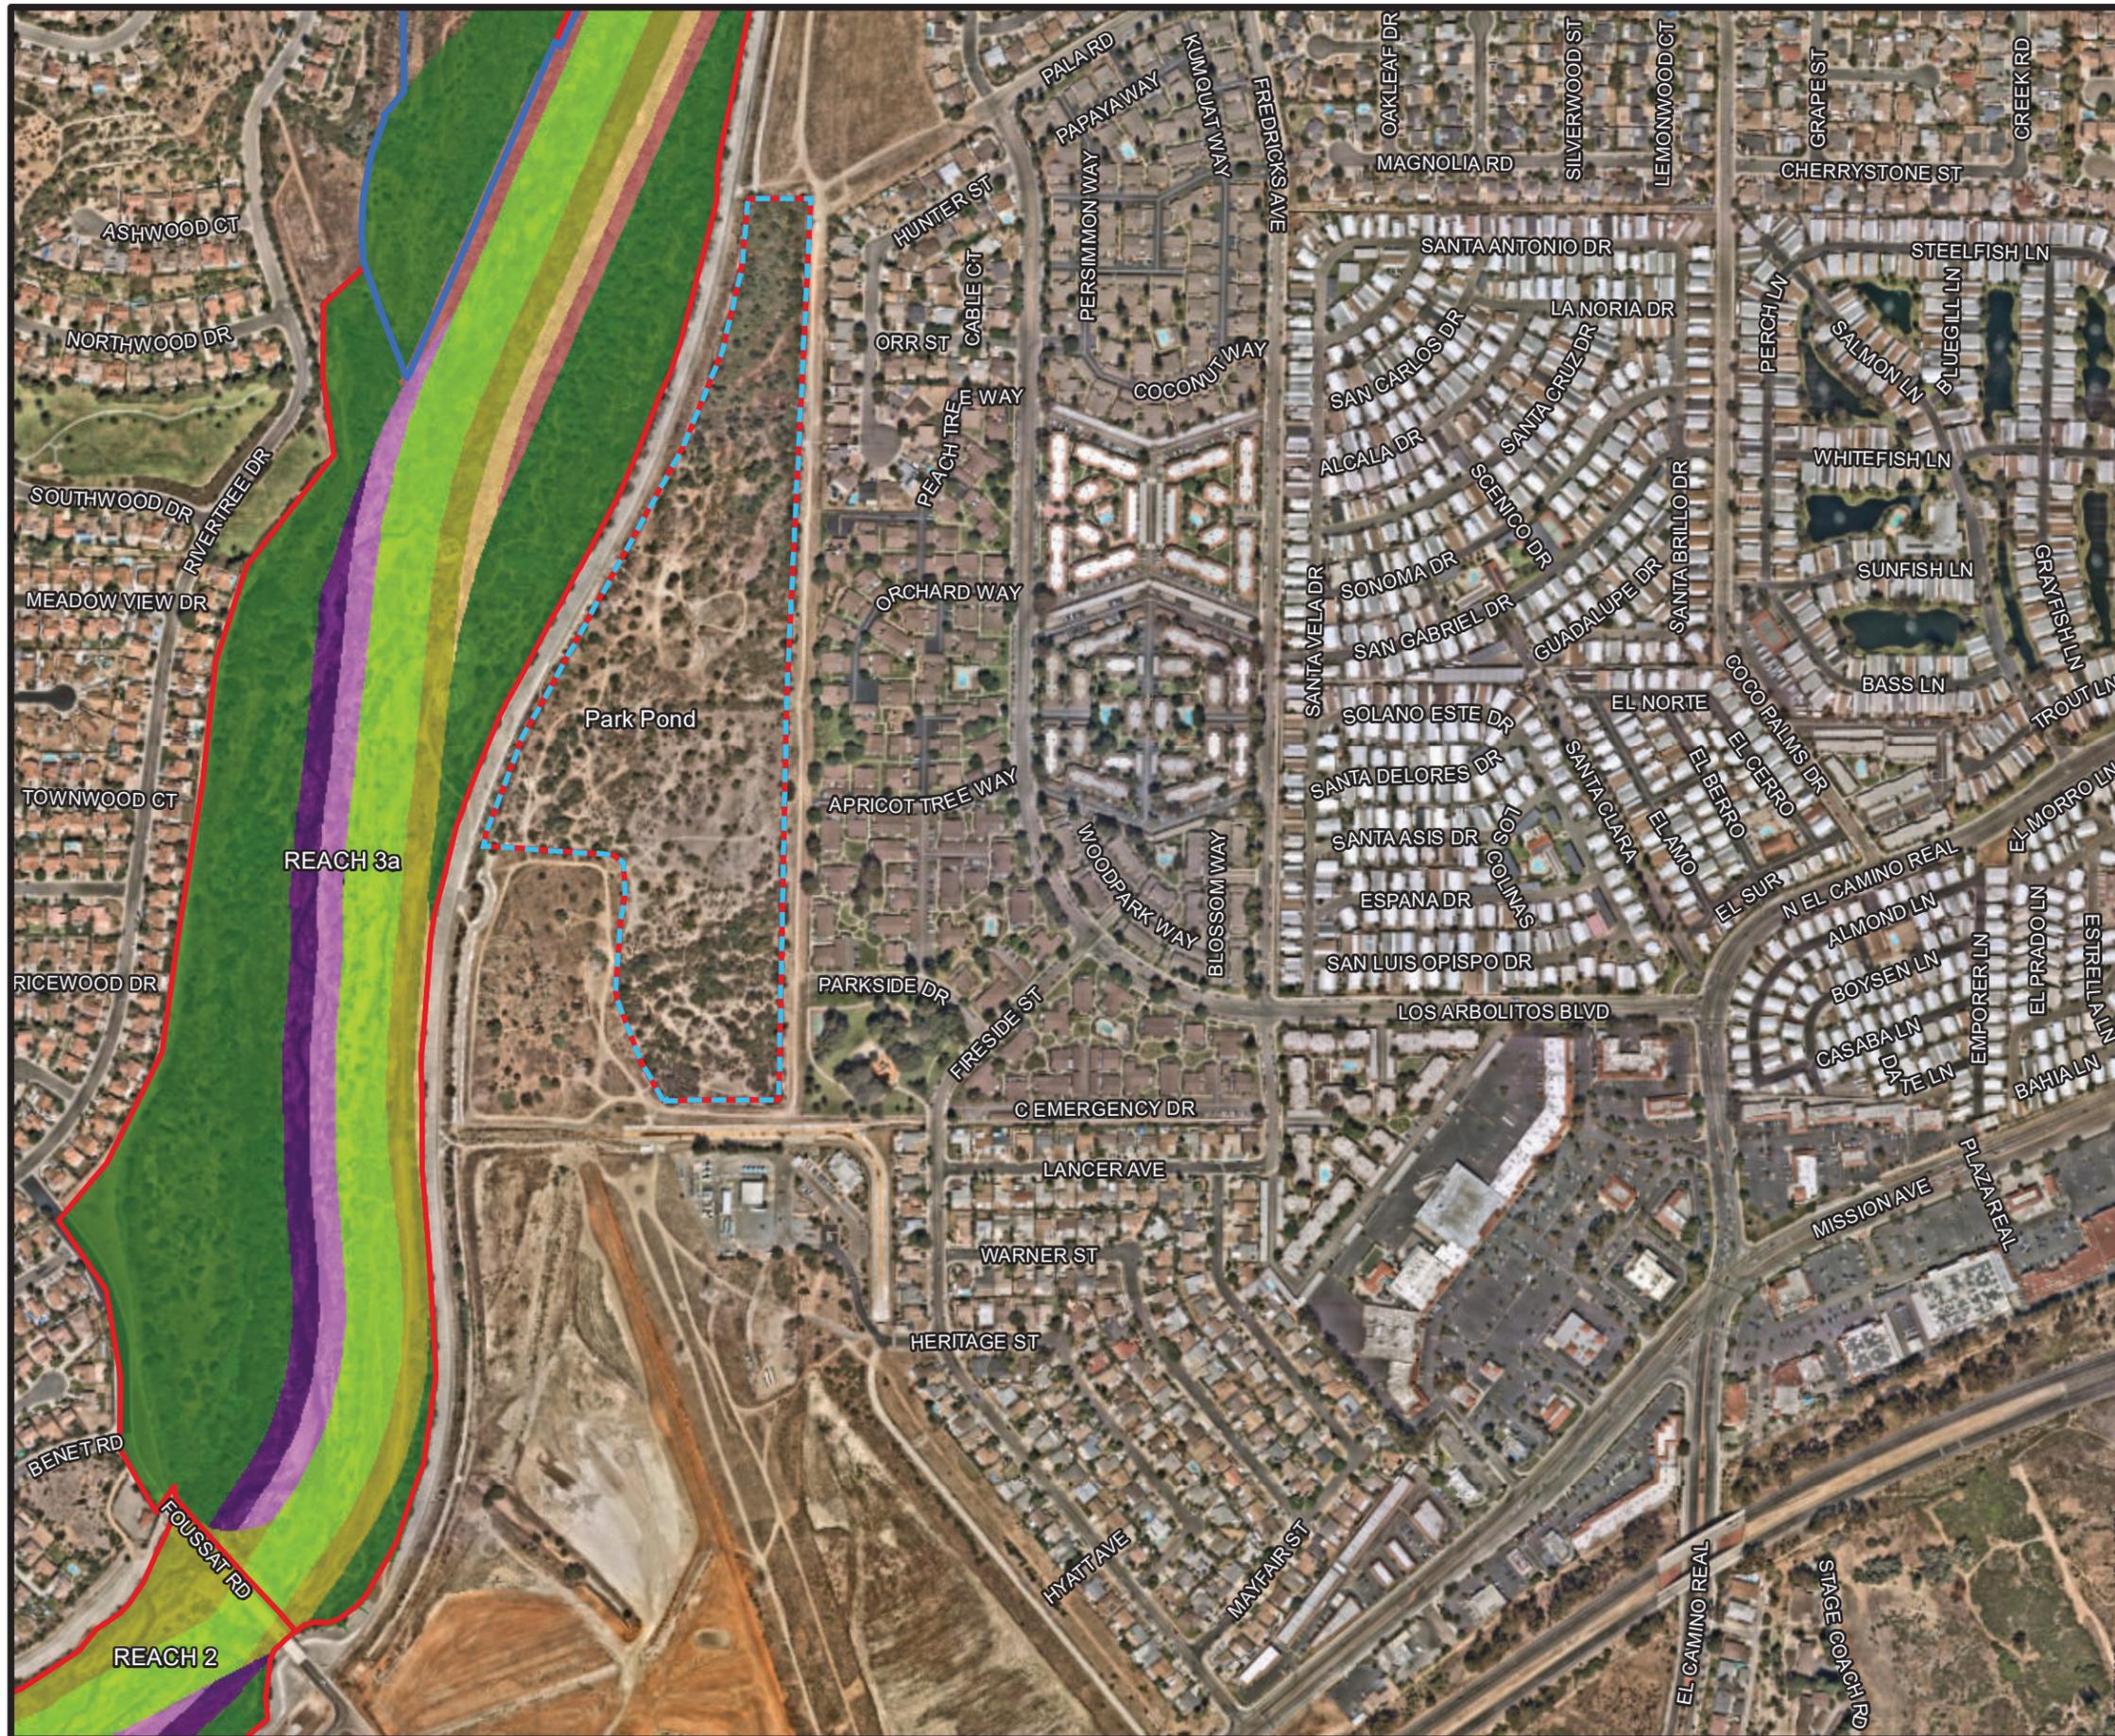
FIGURE 3D
PROJECT AREA ON AERIAL PHOTOGRAPH AND VEGETATION MANAGEMENT PLAN

- Flood Risk Management Area
 - Whelan Restoration Site
 - Water Detention/Mitigation Pond
- Vegetation Management Plan**
- Phase 1 Annual Mowing
 - Phase 2 Annual Mowing
 - Phase 3 Annual Mowing
 - 1st 5-Year Rotational Mowing (Rotation 1)
 - 2nd 5-Year Rotational Mowing (Rotation 2)
 - Compensation/Preservation Area
 - Unmaintained Vegetation

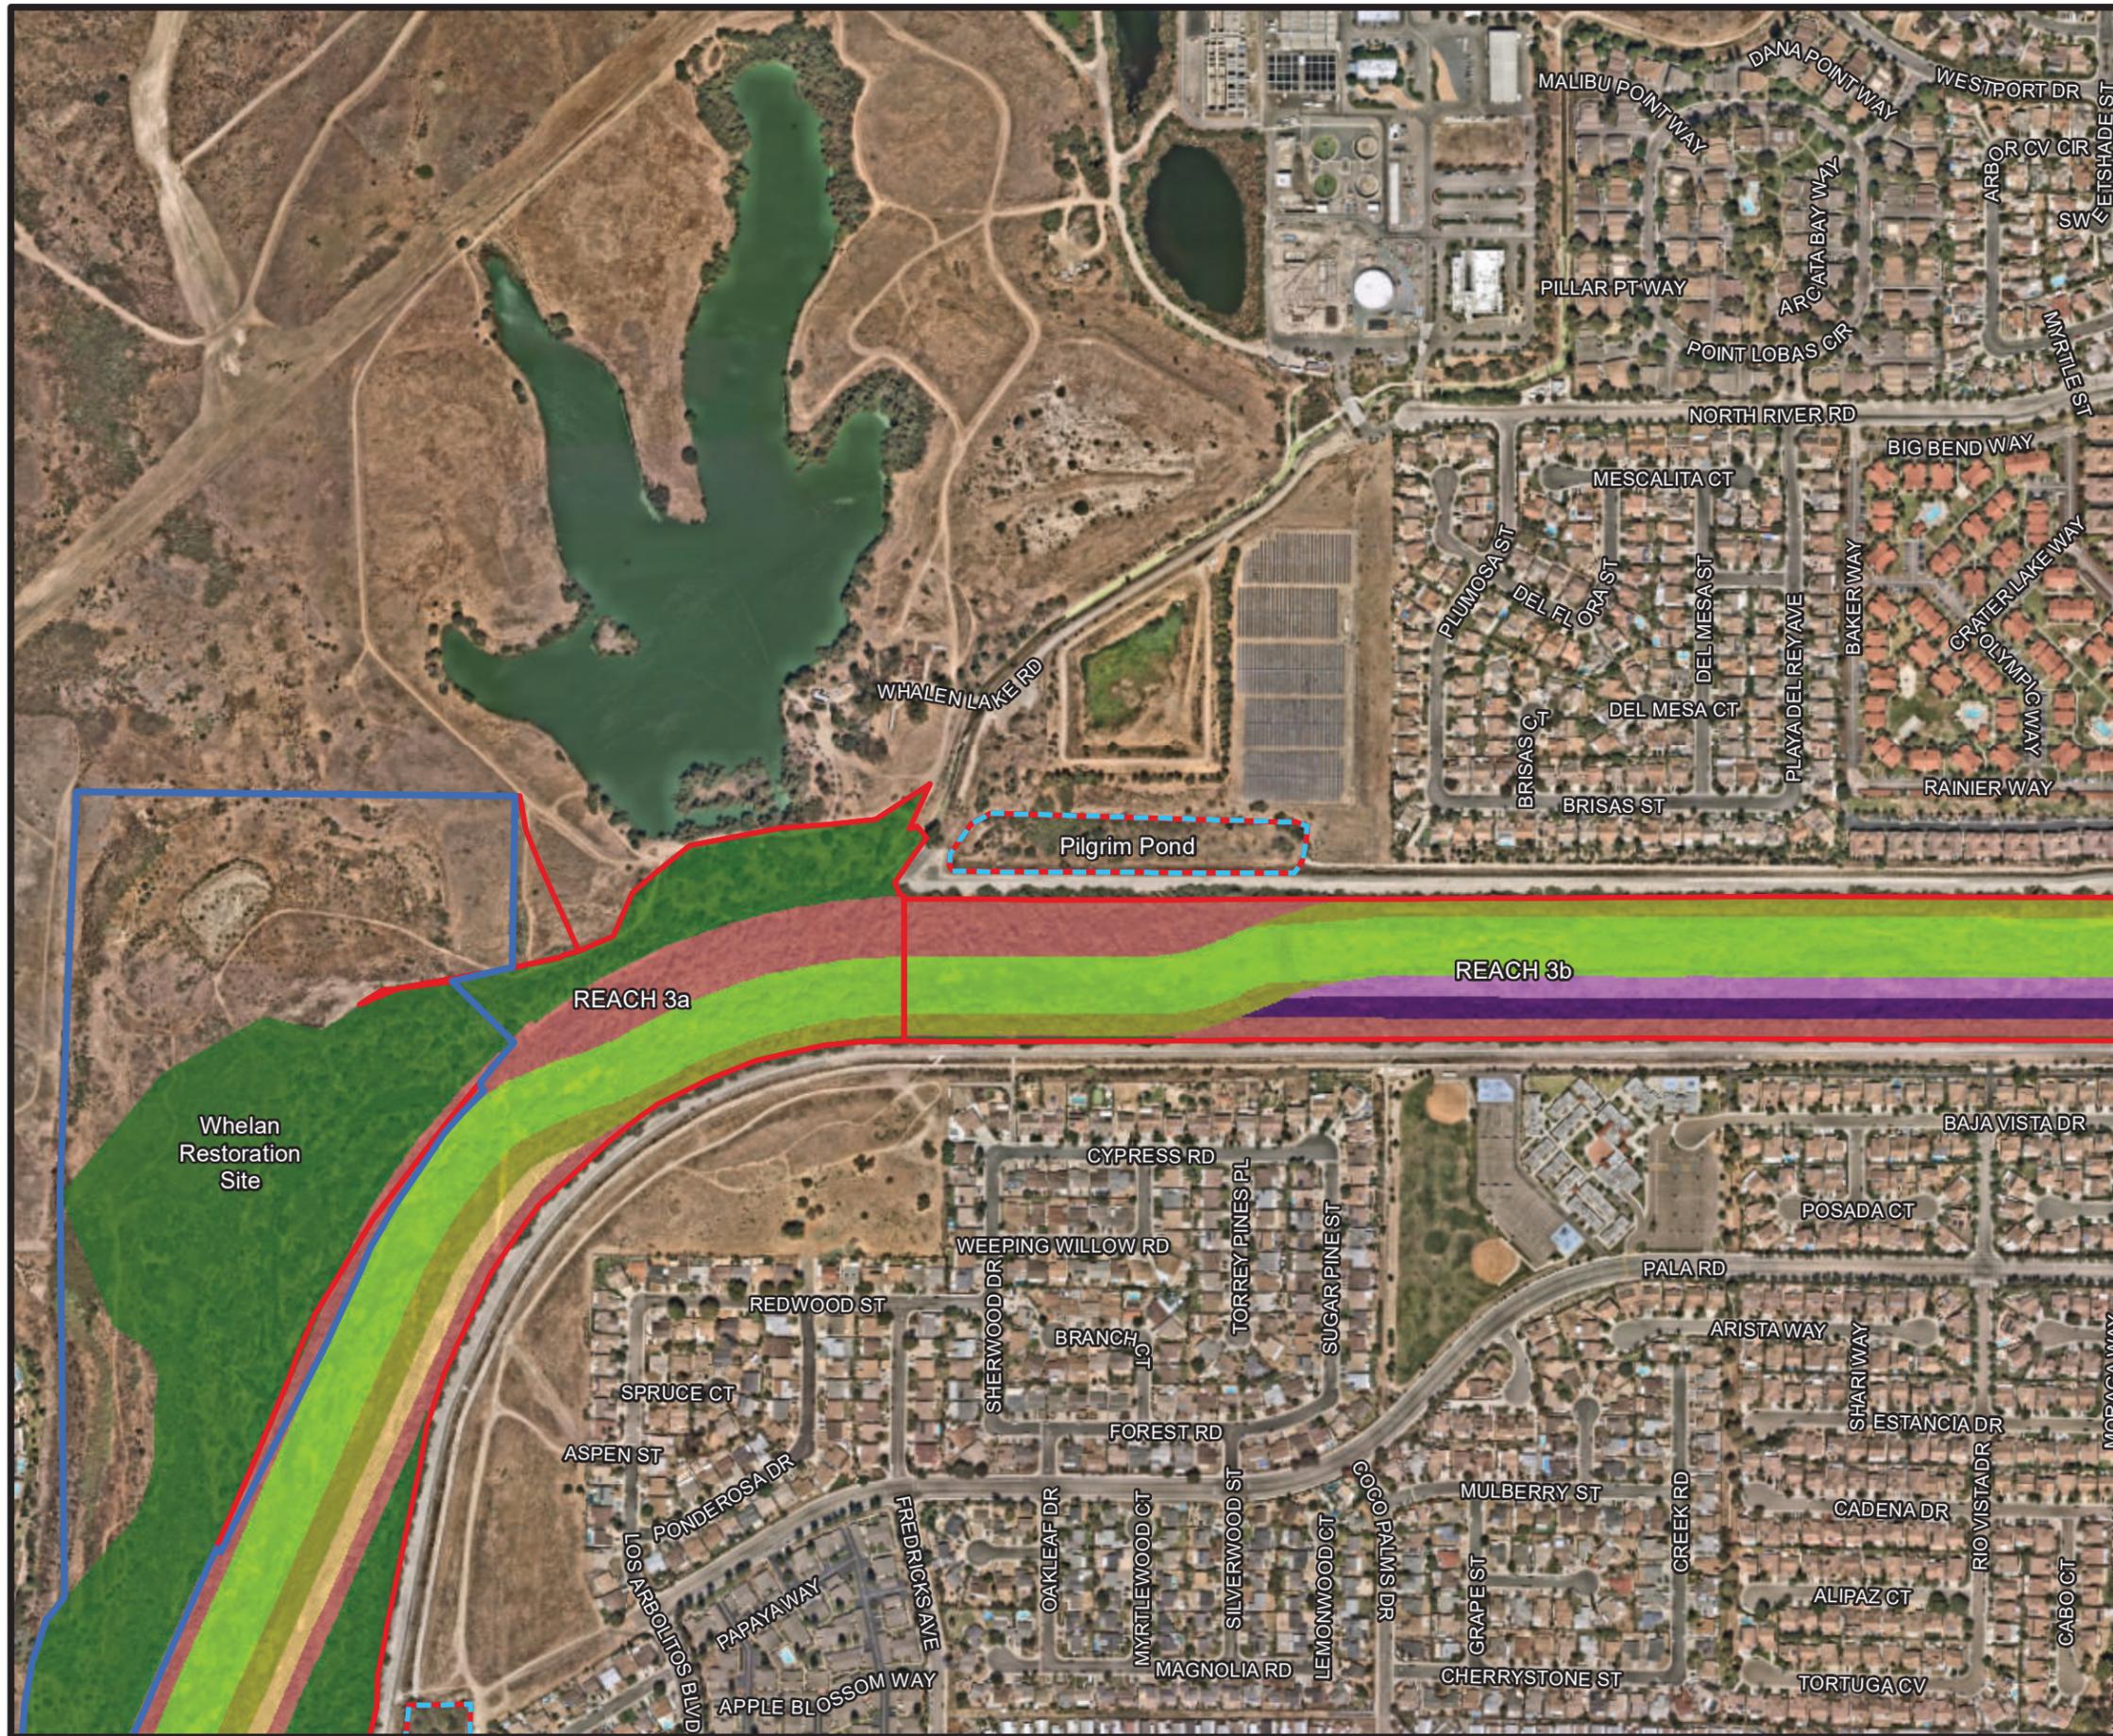
FIGURE 3E
PROJECT AREA ON AERIAL PHOTOGRAPH AND VEGETATION MANAGEMENT PLAN

- Flood Risk Management Area
- Whelan Restoration Site
- Water Detention/Mitigation Pond
- Vegetation Management Plan**
- Phase 1 Annual Mowing
- Phase 2 Annual Mowing
- Phase 3 Annual Mowing
- 1st 5-Year Rotational Mowing (Rotation 1)
- 2nd 5-Year Rotational Mowing (Rotation 2)
- Compensation/Preservation Area
- Unmaintained Vegetation

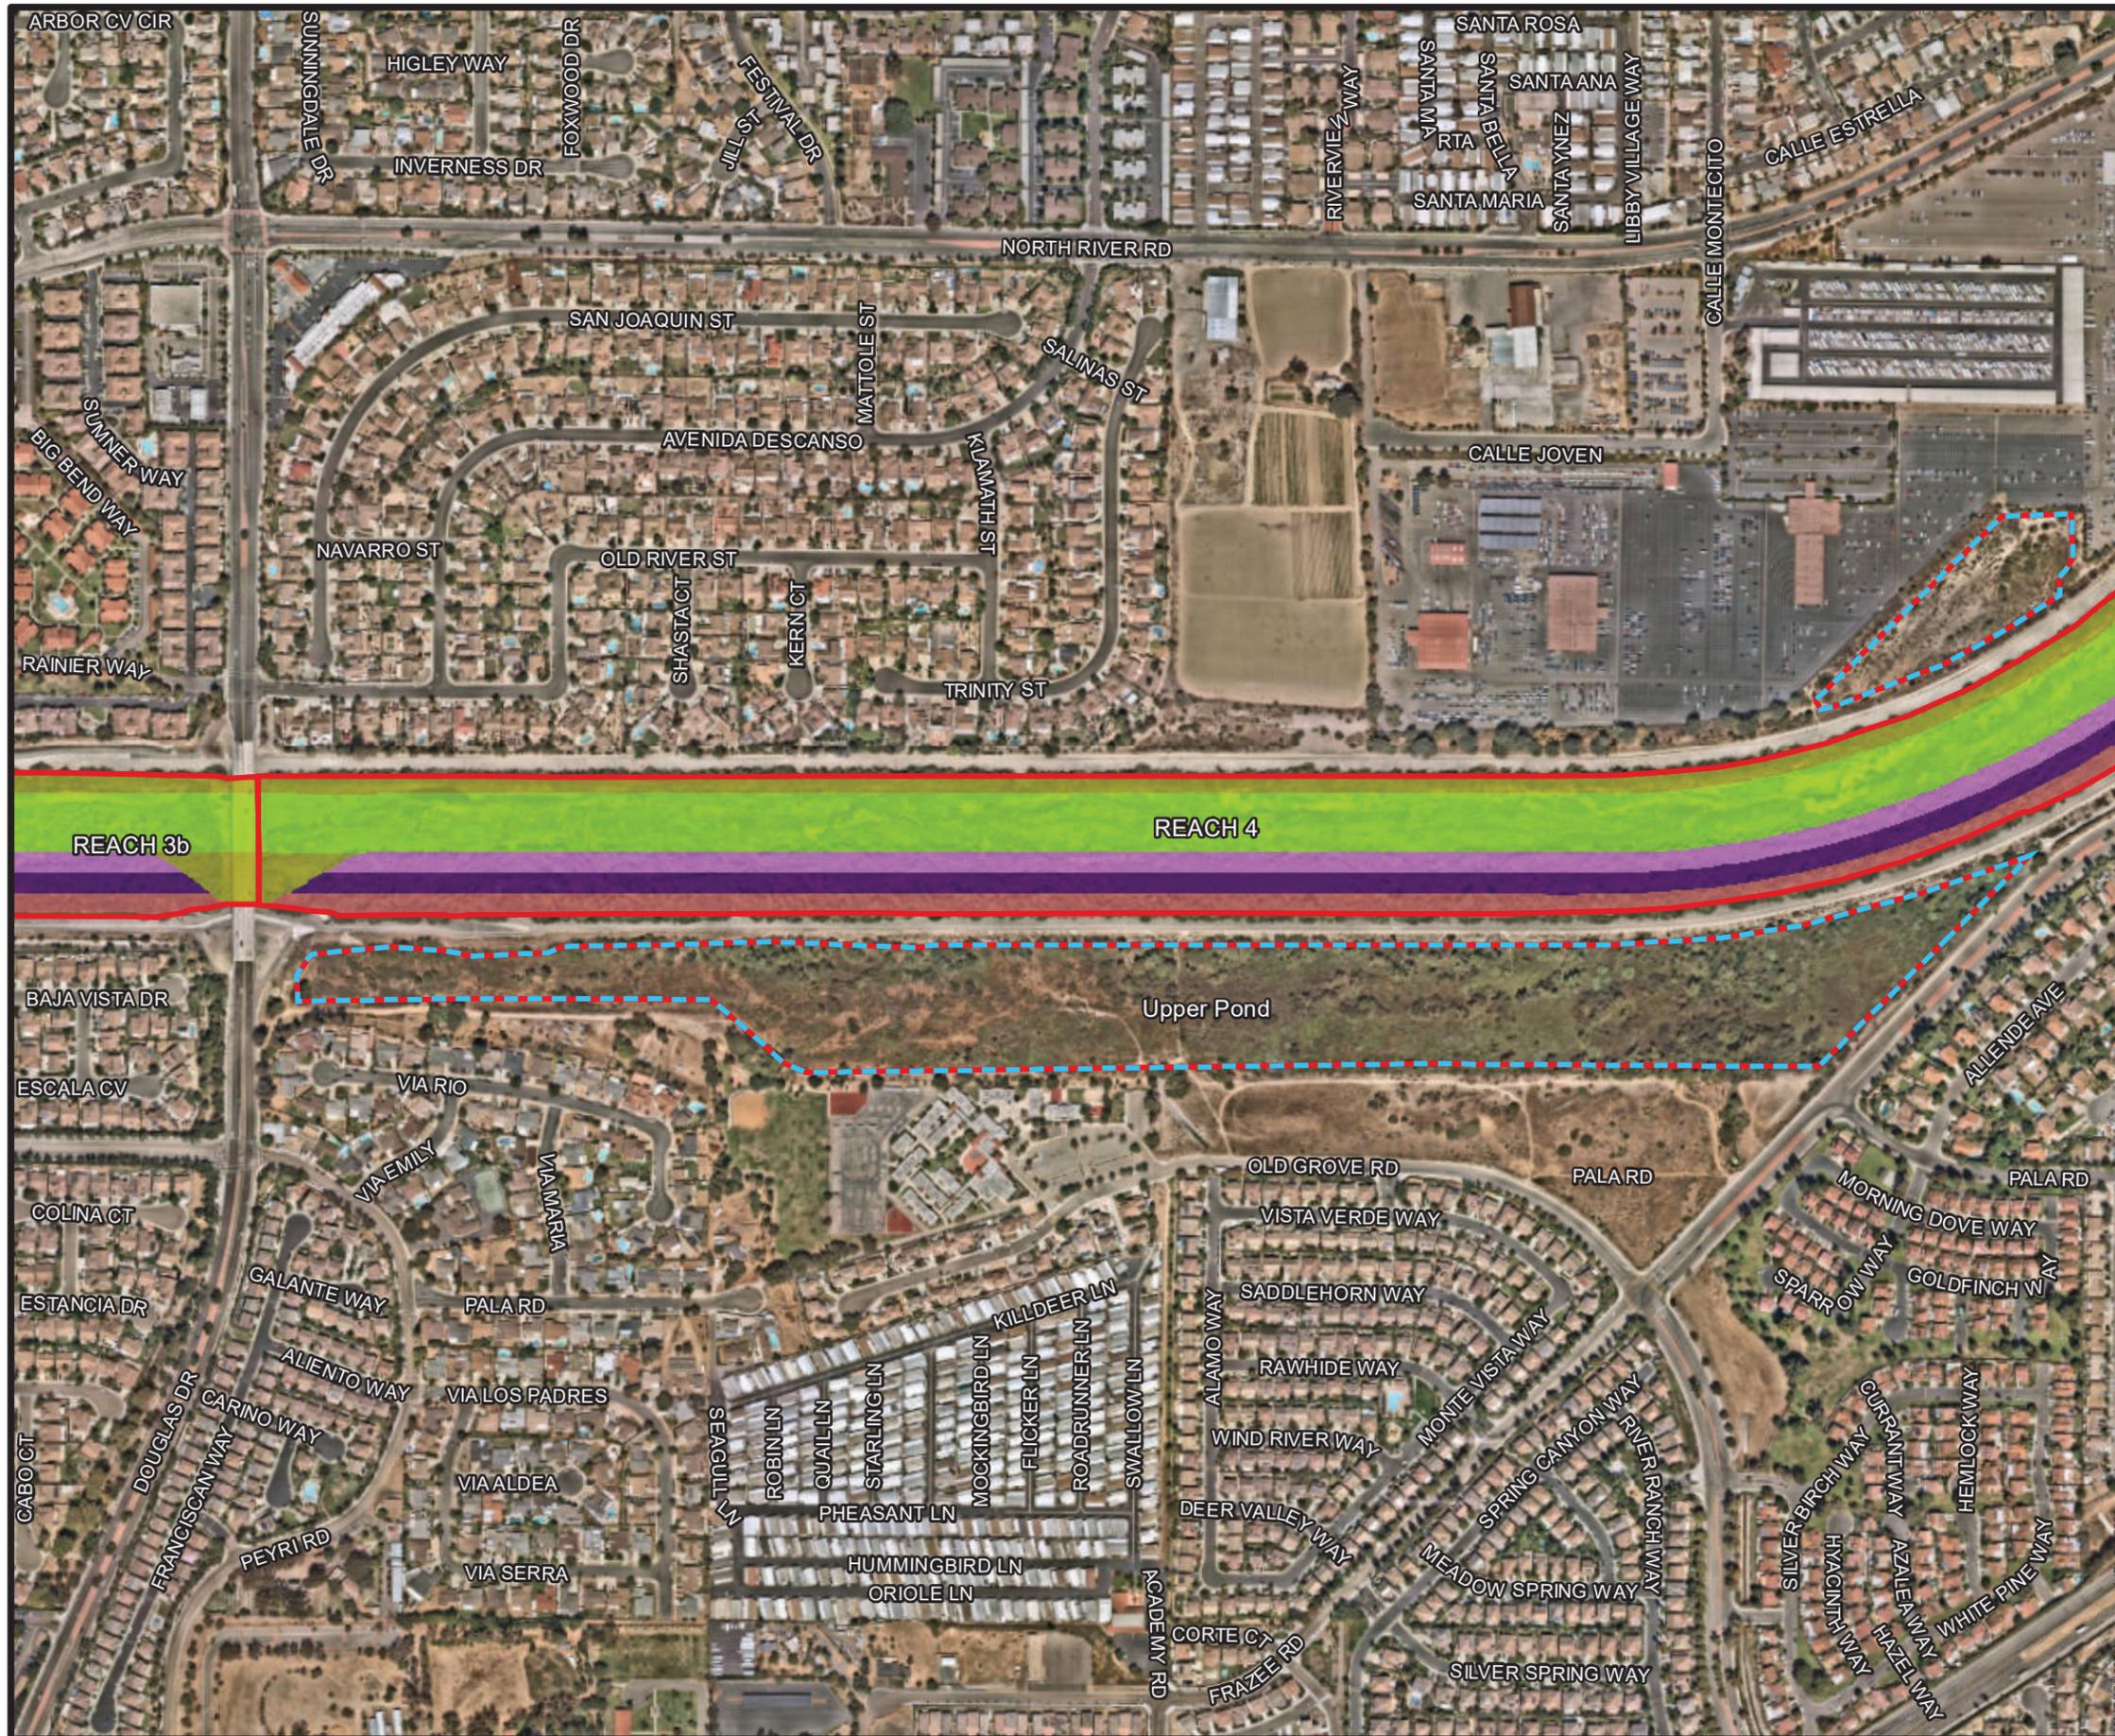
FIGURE 3F
PROJECT AREA ON AERIAL PHOTOGRAPH AND VEGETATION MANAGEMENT PLAN

- Flood Risk Management Area
- Water Detention/Mitigation Pond
- Vegetation Management Plan**
- Phase 1 Annual Mowing
- Phase 2 Annual Mowing
- 1st 5-Year Rotational Mowing (Rotation 1)
- 2nd 5-Year Rotational Mowing (Rotation 2)
- Compensation/Preservation Area
- Unmaintained Vegetation
